# Evaluation of Retroreflective Pavement Markers for Precision and Nonprecision Runways

Guy S. Brown

Prepared By  
FAA Technical Center  
Atlantic City Airport, N.J. 08405

December 1982

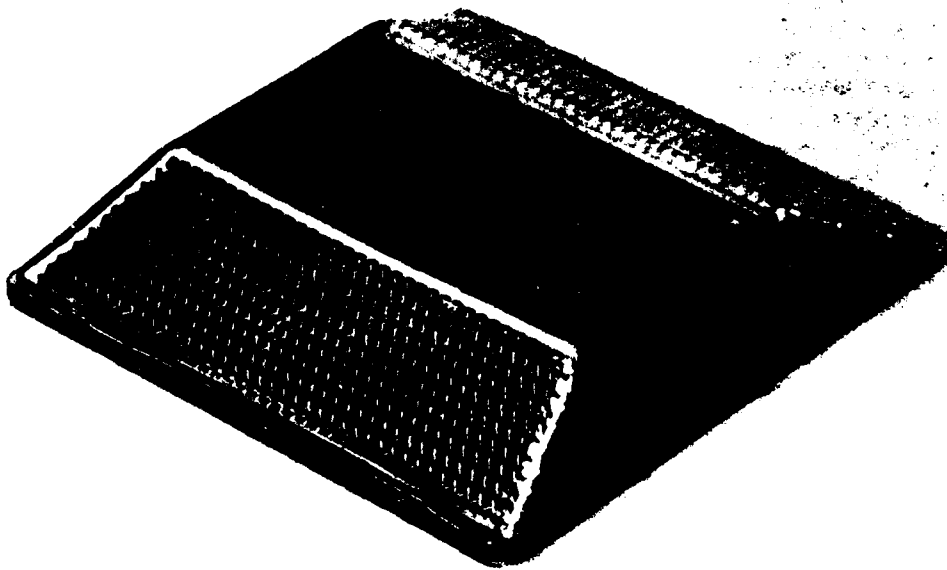
Retroreflective pavement markers (figure 1) consist of an acrylic plastic shell fitted with a potting compound and having overall dimensions of 4 inches by 4 inches by 0.75 inch high. Two sides have sloping surfaces with one or two prismatic reflective faces, as required, to reflect incident light from single or dual directions. The area of each reflecting surface is 3.25 square inch. The unit used for this evaluation was the Stimsonite Model 911 marker which is their Model 88 modified by the company to provide an improved abrasion resistant surface. Surface modification is accomplished by adding a thin layer of untempered glass bonded to the prismatic reflective face. The Model 88 retroreflective marker is listed under Federal Aviation Administration (FAA) Approved Airport Lighting Equipment and Specification L-853 (references 3 and 4).

FIGURE 1. RETROREFLECTIVE PAVEMENT MARKER

The retroreflective pavement markers, made of plastic, are 4 inches square by 0.75 inches high. Two sides have sloping surfaces with one or two prismatic reflective faces as required to reflect incident light from single or dual directions. The markers were installed on runway 4-22 at the Technical Center using an epoxy compound. The spacing and colors used were the same as those specified for Category II centerline and touchdown zone lighting systems.

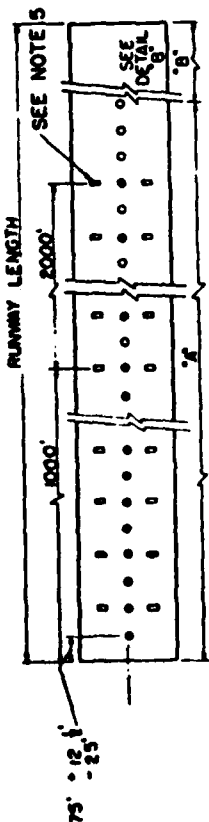
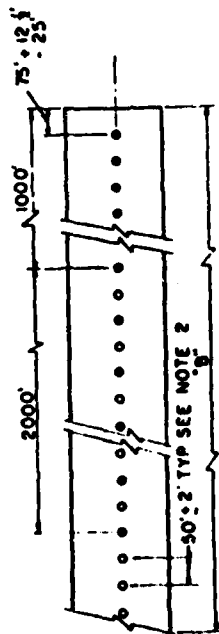
- SYMBOLS**
- - Unidirectional touchdown zone light bar, 3 lights per bar
  - - Bidirectional runway centerline light white both directions
  - row - Centerline lights white (w) one direction and red (r) opposite direction

1. Centerline lights may be offset 2' to the right or left of the runway centerline to avoid the centerline paint markings.
2. The centerline lights may have a longitudinal tolerance of  $\pm 2'$ , a lateral tolerance of  $\pm \frac{1}{8}"$ .
3. The last 3000-foot section of the runway centerline displays an alternate red and white light signal.
4. The last 1000-foot section of the runway centerline displays an all red signal.
5. The touchdown zone light bars are not required to be located at the same stations as the centerline lights. See figure 2 for configuration.

FIGURE A-1. RUNWAY CENTERLINE LIGHTING LAYOUT

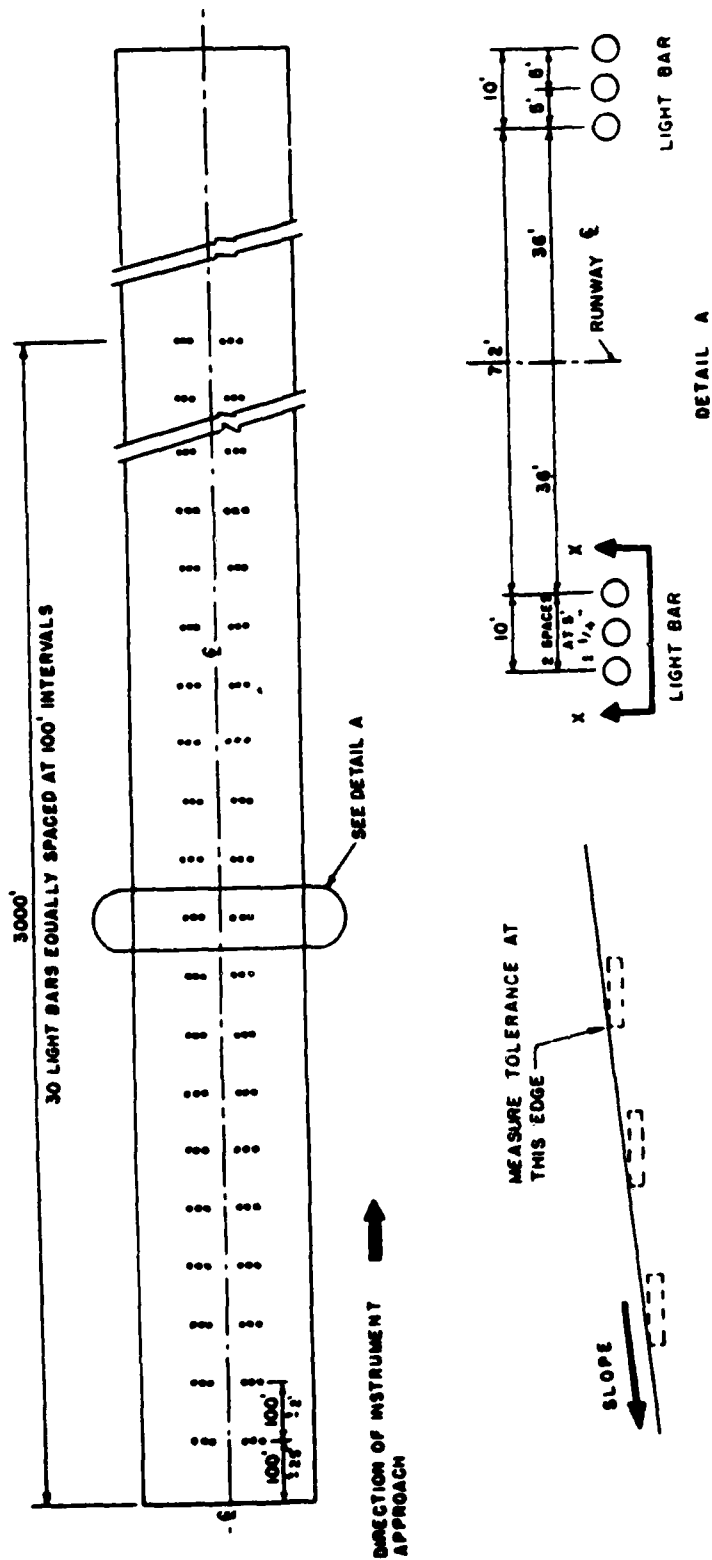
- 1 THE LONGITUDINAL INSTALLATION TOLERANCE IN LOCATING THE PAIRS OF TRANSVERSE LIGHT BARS SHOULD NOT EXCEED 2 FEET LATERAL TOLERANCE OF LIGHTS IN A BAR IS  $\pm 1/4$
- 2 THE SPACING BETWEEN THE INNERMOST TOUCHDOWN ZONE LIGHT FIXTURES SHOULD BE UNIFORM THROUGHOUT THE LENGTH OF THE SYSTEM THIS SPACING IS 72 FEET EXCEPT WHERE CONSTRUCTION PROBLEMS PREVENT THIS SEPARATION IN THIS CASE. THE UNIFORM SPACING IS REDUCED TO NOT LESS THAN 65 FEET.
